## TECHNICAL MEMORANDUM

DATE: October 29, 2013  
TO: Mary Millner, SME, EPA Region 10  
FROM: Julie Sharp-Dahl, Project Manager  
Bristol Environmental Remediation Services, LLC  
RE: EPA Contract No. EP-W-12-009  
Task Order (TO) B-7, Amendment 1, Western Gas Corrective Action

Bristol Environmental Remediation Services, LLC (Bristol), has prepared this Technical Memorandum (Tech Memo) at the request of the U.S. Environmental Protection Agency (EPA). The Tech Memo provides results for September 2013 activities conducted at the Western Gas Leaking Underground Storage Tank (LUST) site, located on the Yakama Nation, in Toppenish, Washington. The tasks associated with TO B-7, Amendment 1 included planning and initiating corrective action at the Western Gas site.

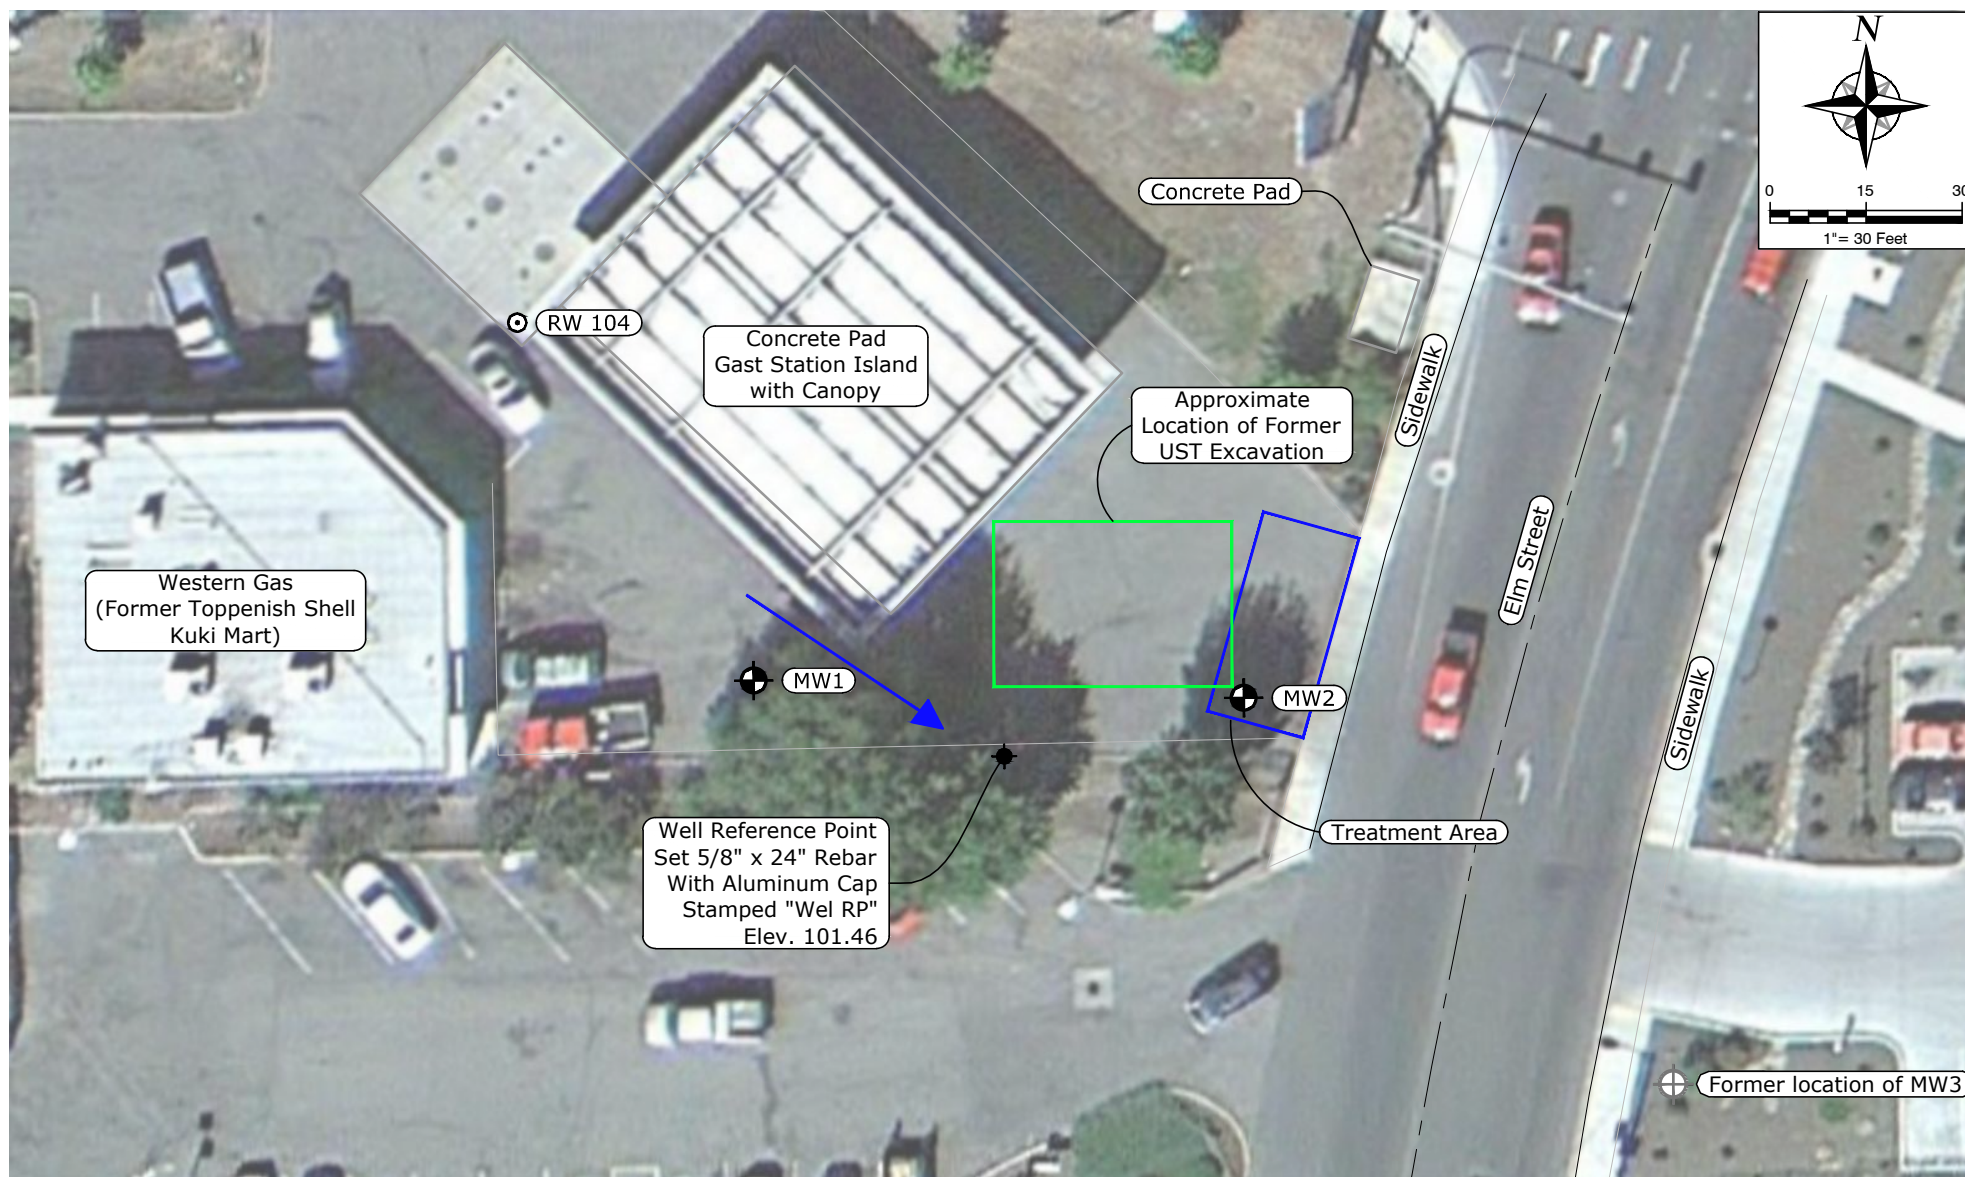
FIGURE 2  
 EPA B-7 WESTERN GAS  
 401 S. ELM ST.  
 TOPPENISH, WA 98948  
**SITE MAP**

Groundwater is located approximately 13 feet below ground surface (bgs) with seasonal variations of 6-8 feet which are a function of irrigation and recharge (EPA, 1997). In general, groundwater flows to the southeast. There is a municipal water supply well approximately 1,000 feet east-southeast of the site. Site soils consist of clayey silt mixed with sand and gravel to a depth of 7 to 10 feet bgs and silty, sandy, gravel with cobbles below the clayey silt.

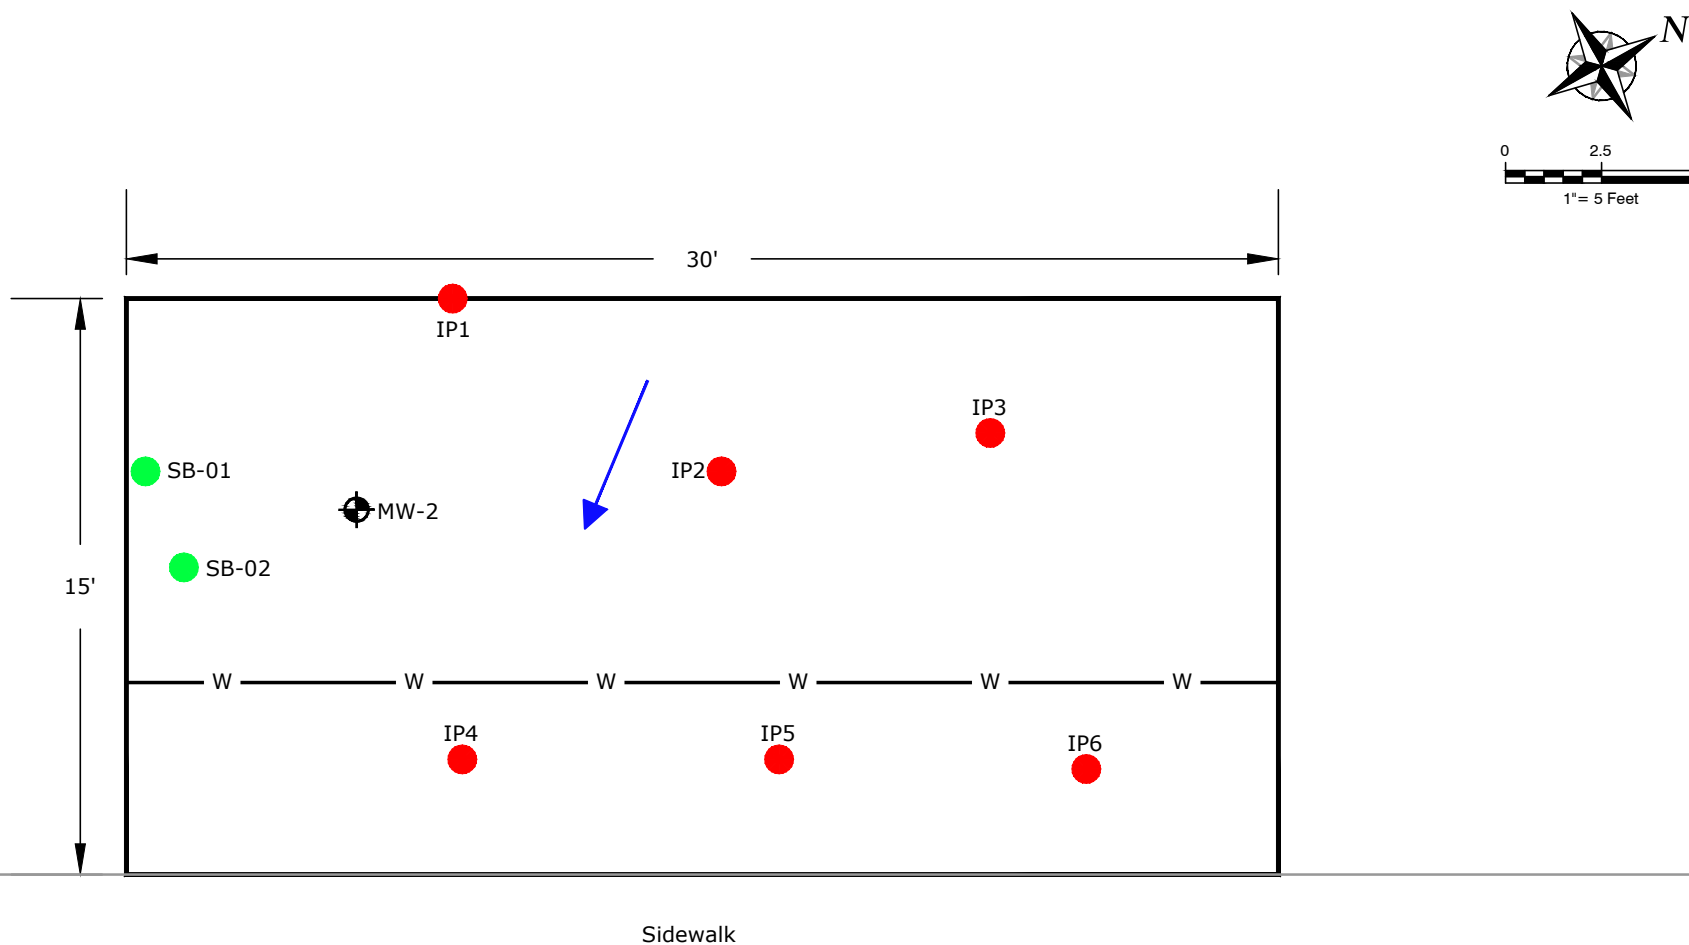
FIGURE 3  
 EPA B-7 WESTERN GAS  
 401 S. ELM ST.  
 TOPPENISH, WA 98948  
**TREATMENT AREA MAP**

Through these means, only one underground utility was identified running through the treatment area, a currently unused water line for landscape irrigation (Figure 3).

Soil borings were advanced using direct-push drilling technology. Continuous cores from the two borings were collected using a Macro-Core soil sampler into 5-foot acetate sleeves. The cored soil boring locations are depicted on Figure 3.

The six injection points (IP1 through IP6) are depicted on Figure 3. The treatment interval for each injection point was 16 to 19 feet bgs, based on descriptions of the impacted soil interval from the 1995 soil removal. For each injection point, the following volumes and quantities were used to achieve a 5% oxidizer solution (as recommended by Regenesis): 57 gallons of water, 25 pounds of RegenOx Part A, and 11 pounds of RegenOx Part B. For each injection point, one third of the RegenOx solution designated for that point was injected into each of three depths within the treatment interval.

Upon arrival at the Western Gas site, the injection supervisor from Bristol's drilling/injection subcontractor (PS&W) expressed concern that the proposed locations for the cored borings were too close to the injection points, and had the potential of becoming pathways for the injected RegenOx. This could prevent dissemination of the RegenOx into the desired subsurface interval. The PS&W injection supervisor recommended minimizing the number of cored borings and moving them as far from injection points as practical. Upon consultation with the EPA SME, who was onsite, and the Bristol project manager, the number of cored borings was reduced to one, and the proposed location of the boring was moved up against the southwest boundary of the treatment area (SB-01 on Figure 3).

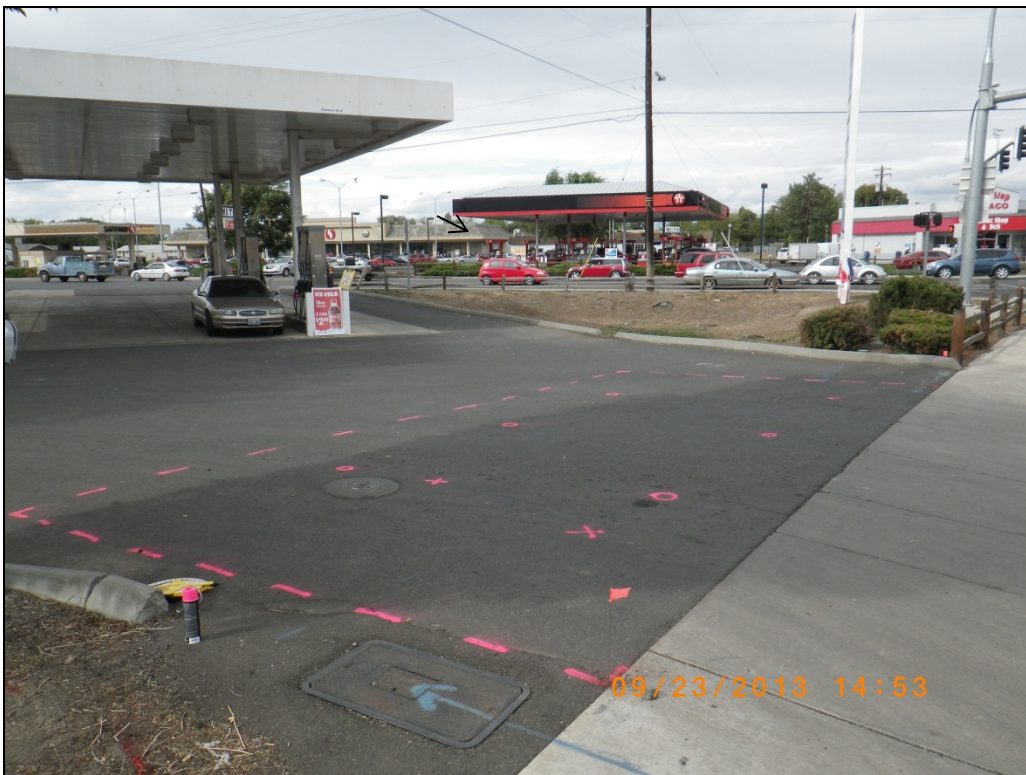
**Photo 1:** Treatment area with proposed injection points and soil boring locations marked in pink paint  
**Direction:** North

Upon arrival on the Western Gas site on the afternoon of September 23, Bristol personnel identified the location of the treatment area proposed in the Corrective Action Plan (Bristol, 2013b) and marked its boundaries with pink marking paint. The treatment area was defined in the Corrective Action Plan as a rectangle measuring 30 feet long by 15 feet wide, located between the former soil excavation and Elm Street (Figure 2). Bristol personnel also marked the proposed locations for the six injection points, as well as proposed locations for the two cored soil borings.

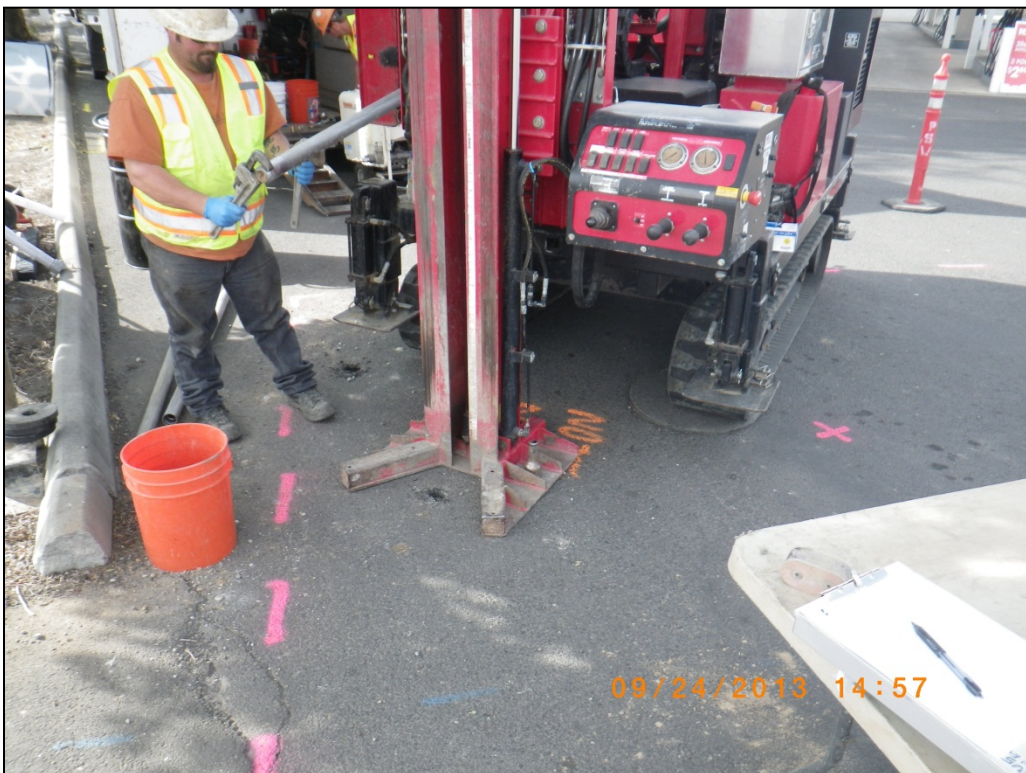
**Photo 2:** Drill crew coring soil boring SB-02  
**Direction:** Northwest

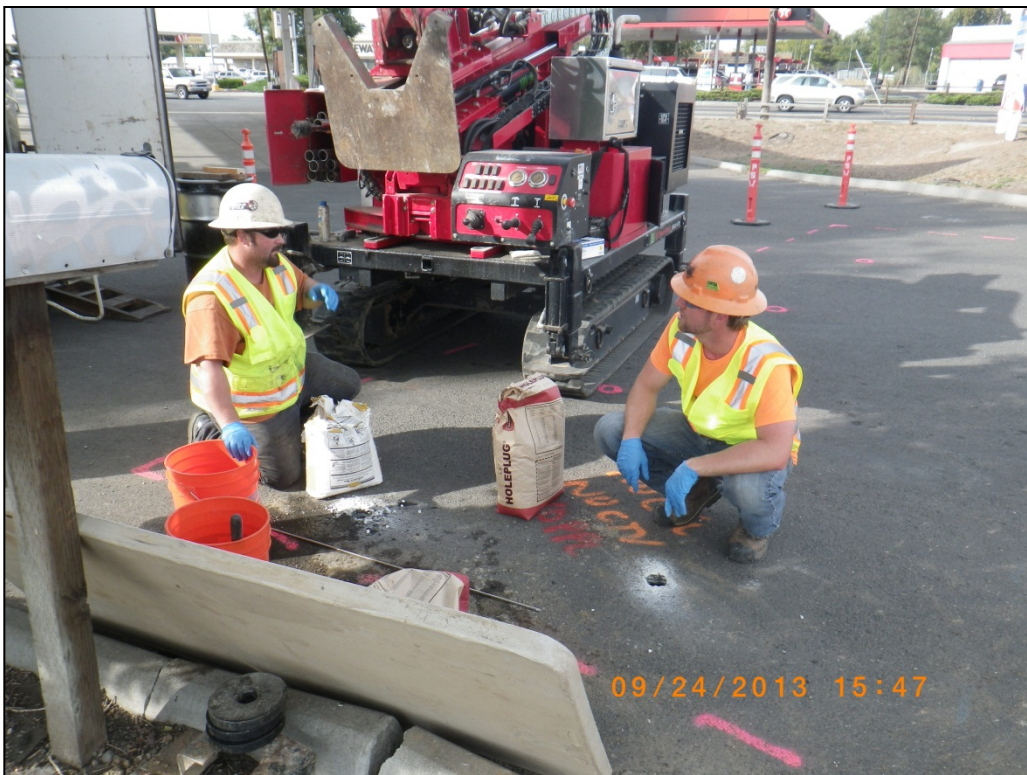
**Photo 3:** Drill crew grouting and patching soil boring  
SB-02

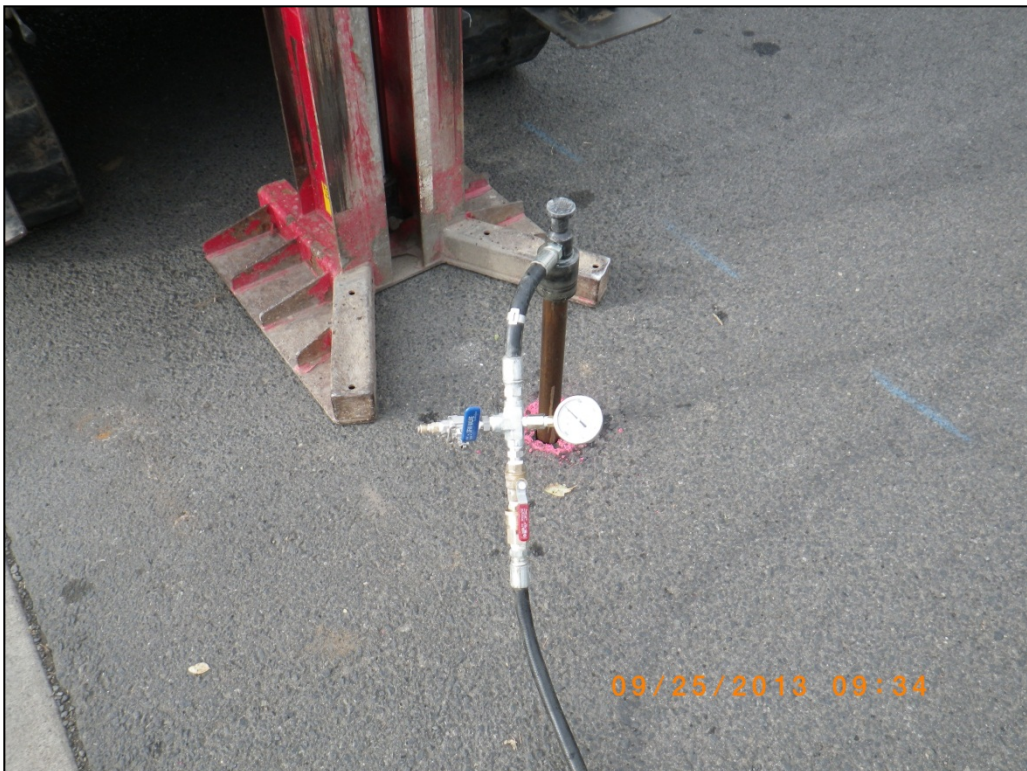
**Photo 4:** Injection point IP-06 with pressure gauge

The majority of the injections were performed without an appreciable increase in pressure at the injection manifold. However, during the injection at IP6, pressure would momentarily rise as high as 200 pounds per square inch (PSI). The pressure would immediately drop back to 0 PSI when the injection pump cycled off. The driller/injection subcontractor slowed the pump rate to its lowest setting to avoid over-pressurizing the injection point.

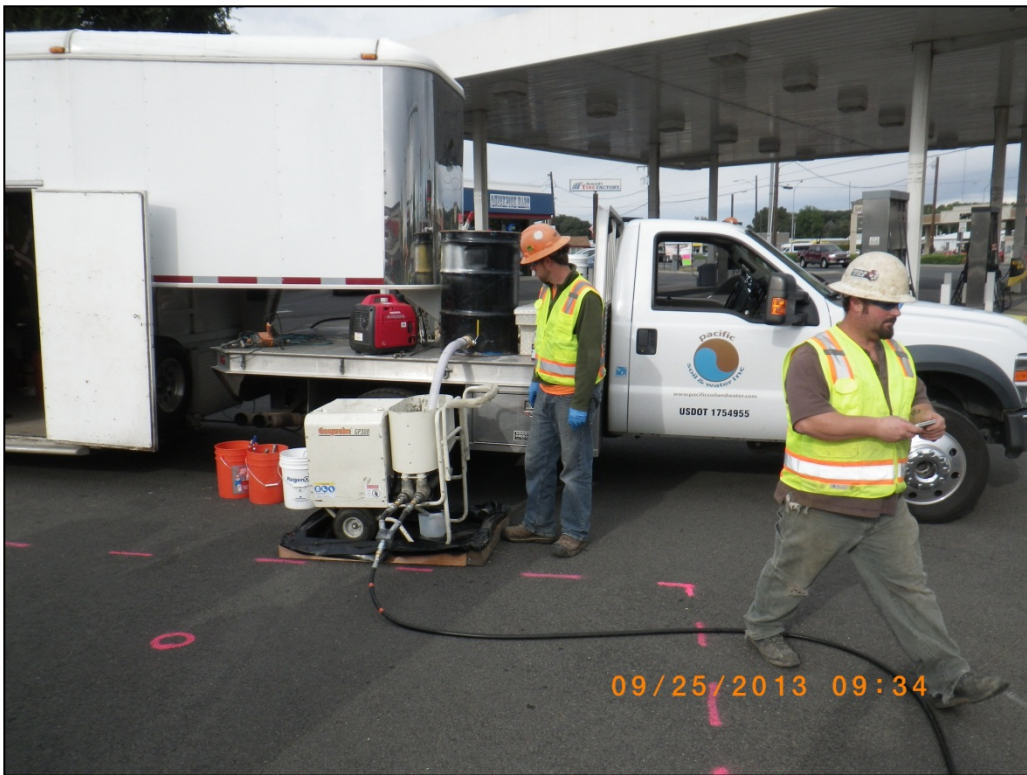
**Photo 5:** Injection pump and hopper set up for injection point IP-06  
**Direction:** West

Half of the RegenOx solution needed for that injection point was then mixed in a 55-gallon drum outfitted with valve at the bottom of the drum. The drum was staged on a platform so that the valve was located above the injection pump, allowing it to be gravity-fed into the pump's hopper. For each batch of solution, a premeasured volume of water was added to the drum, followed by a premeasured amount of RegenOx Part A, and then the solution was mixed until the oxidizer was dissolved. Then, a premeasured amount of RegenOx Part B was added and the solution was mixed for at least 5 minutes. The solution was then gravity fed into the injection pump hopper. As the hopper had a maximum volume of 10 gallons, each batch of RegenOx filled the hopper twice.

Once the hopper was prepared, an injection manifold (outfitted with a pressure gauge and a release valve) was connected to the top of the drive rods, and the injection pump was connected to the injection manifold with a hose. The 57 gallons of RegenOx was then injected into the treatment interval with the bottom of the pre-probe at three different depths: 19, 17.75, and 16.5 feet bgs. At each depth, one third (approximately 19 gallons) of the RegenOx solution prepared for that injection point was injected. When the injection was complete, the pre-probe and drive rods were removed and the open borehole was slowly filled with bentonite pellets to within 0.5 feet of the ground surface. The borehole was then finished with a surface seal of quick-set concrete, and an asphalt patch.

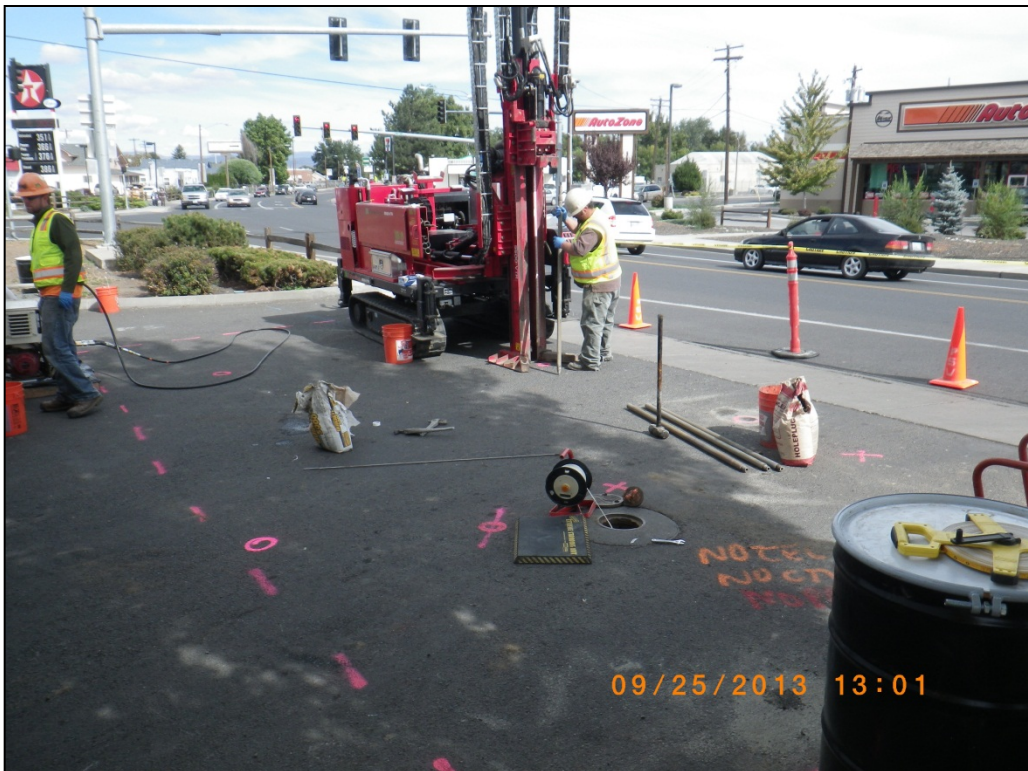
**Photo 6:** Driving injection point IP-05  
**Direction:** Northeast

At each injection point, the pre-probe with an expendable tip was initially driven to the bottom of the treatment interval (19 feet bgs) using standard 1-inch diameter drive rods, and the expendable tip was disconnected.
